# WORLD HERITAGE AND DEGRADATION

Aversa | Naples 16 - Capri 17, 18 June 2016

### Investigations about the causes of structural damages of the St. Bernardino convent in Amantea (Cs)

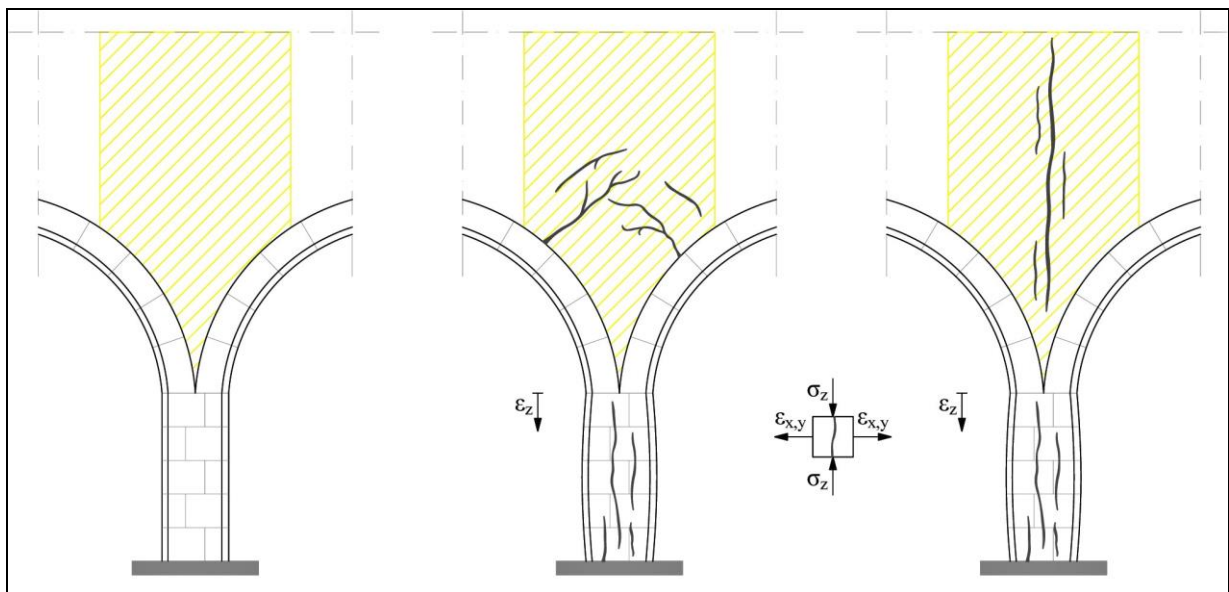
Usually, on the arcades of the cloister affected by the instability in act, a vertical "shortening" and a horizontal transversal expansion on the generic pillar are detected [5]. The lowering of the pillar entails the excess of the internal cohesion on the filling portion of masonry placed between two load-bearing semi-arches, supported by the slender element (fig. 2.a). This involves the formation of cracks with a parabolic trend on the filling masonry portions (fig. 2.b). The phenomenon described manifests in presence of overloaded arches affected by an advanced crushing instability. However a different trend of the cracks, on the filling masonry portions, has been detected in correspondence of two pillars located along the west front (this is the side of the cloister along which the overloading produces the heaviest effects). On these masonry portions the cracks have not more a parabolic trend, but they are approximately vertical (fig. 2.c).

**Figs. 2:** Investigated crack pattern: a) indication about the filling portion masonry on which the unusual lesions have been detected; b) classical crack pattern with a "parabolic" trend along the filling masonry; c) unusual crack pattern consisted from almost vertical lesions along the filling masonry.

This strange trend of the cracks on the filling portions has suggested to carry out further investigations in order to look for an intrinsic cause to the masonry that could explain a similar "anomaly." In fact, these vertical cracks cannot be attributed to the crushing phenomenon in virtue of ongoing collapse mechanism on the slender load-bearing elements (the pillars). For these reasons, it was decided to carry out endoscopic tests on the pillars of the cloister in order to investigate the masonry structure internally.

The images taken during this third inspection have shown how the metal tube has a length greater than that of the pillar. Even if additional holes have not been performed, it's possible to affirm almost certainly that the metal element has a length equal to the share of the floor of the first level. The metal tube was used as an element of reinforcement for the masonry; in fact, it is able to collaborate to the load-bearing function of the masonry body within which it has been inserted. Furthermore, the development in height of the metal tube, its oxidation and the consequent volumetric expansion explain the appearance of the vertical unusual cracks on the filling portions of masonry placed between two load-bearing semi-arches, as those supported by the pillar investigated P.1. (fig. 2.c).

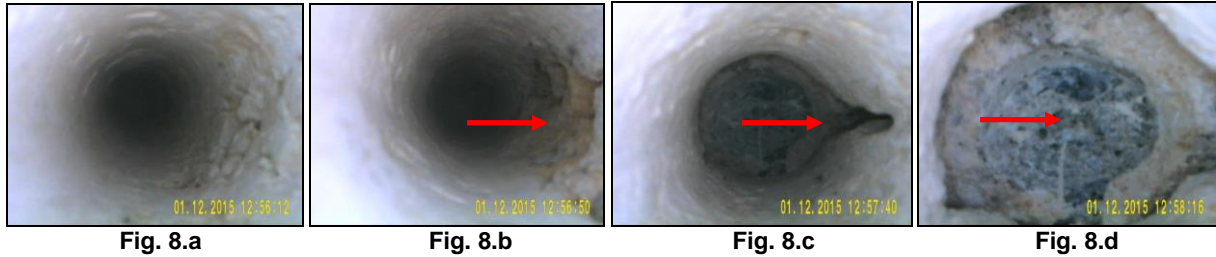
- for  $0 \leq x < 10$  cm, the calcarenite stone is devoid of anomalies (fig. 8.a);
- for  $10 \leq x < 15$  cm, the calcarenite stone shows a longitudinal crack (fig. 8.b);
- for  $15 \leq x < 16$  cm, there is an empty space produced by the separation between the masonry and an internal metal element (fig. 8.c);
- for  $x = 16$  cm the presence of a metallic oxidized element can be observed (fig. 8.d).

**Figs. 8:** Endoscopic investigations throught the first hole realized on the pillar P.1: a)  $0 \leq x < 10$  cm; b)  $10 \leq x < 15$  cm; c)  $15 \leq x < 16$  cm; d)  $x = 16$  cm.

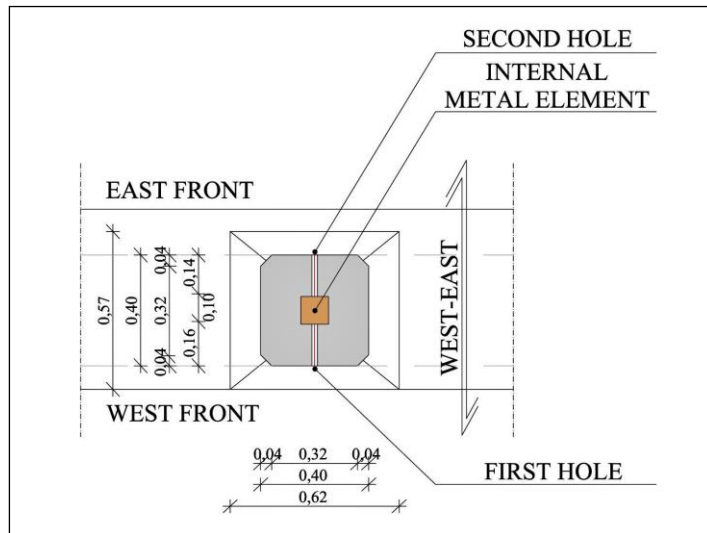
**Fig. 10**

Thanks to the two specular holes, performed on the first pillar, it was possible to discover the internal presence, ignored entirely up to this moment also from the specialists of the Superintendence, of a metal element, of box-shaped type probably, with a quadrangular cross-section having a side of dimension 10 cm (or a circular cross-section, if the drilled holes correspond perfectly with the extremes of a diameter equal to  $\Phi = 10$  cm) (fig. 10). Moreover, thanks to the endoscopic images taken, the

**Fig. 10:** Generic cross-section of the pillar P.1, with indications about the holes performed.

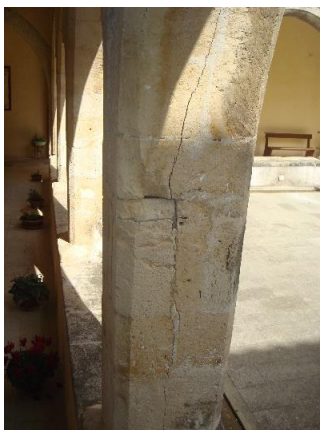
**Fig. 11.a**

oxidation of the metal element has been observed, which has produced the detachment between the internal element of reinforcement and the surrounding masonry due to the resulting increase of the metal volume. Therefore, the oxidation of the metal element has generated, from inside the pillar, a horizontal thrust on the surrounding masonry. This is explained by the presence of empty spaces between the reinforced metal element and the masonry, as well as by the damages that from the inside the pillar are developed up to the outer surfaces. The so produced instabilities are amplified by major internal stresses to the masonry due to the vertical loads of the superstructure. The complicated situation described is shown by the common cracks pattern (fig. 11.a), the expulsion of stone elements from the masonry bodies (fig. 11.b) and the reduction of the resistant cross-sections (fig. 11.c).

**Figg 11:** Typical forms of instability on the pillars of the cloister of San Bernardino: a) diffused longitudinal cracks; b) expulsion of corner elements from the masonry body; c) reduction of the resistant cross-sections.

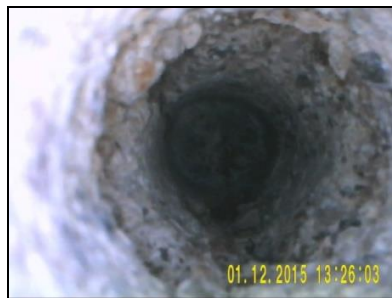
Fig. 12.a

- for  $0 \leq x < 12$  cm, the calcarenite stone / the c is devoid of anomalies (fig. 12.a);
- for  $12 \leq x < 14$  cm, the calcarenite stone / the mortar shows a longitudinal crack (fig. 12.b);
- for  $x = 14$  cm the presence of a metallic oxidized element can be observed (fig. 12.c).

**Figs. 12:** Endoscopic investigation performed through the third hole carried out on the pillar P.1: a)  $0 \leq x < 12$  cm; b)  $12 \leq x < 14$  cm; c)  $x = 14$  cm.

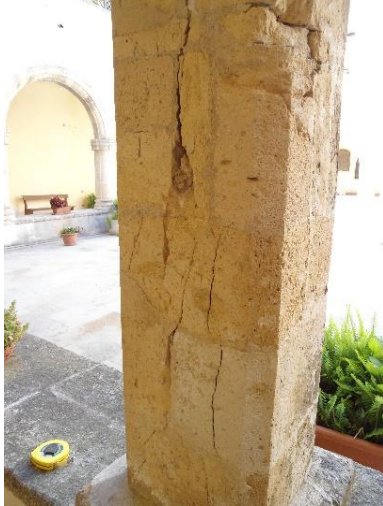
**Fig. 13**

The results have shown how the pillars P.2 and P.3 are affected by the same problem detected on the pillar P.1, due to the presence of internal metal tubes, probably having the same characteristics as the one characterizing the pillar P.1. Furthermore, these metal elements are oxidized and, because of the oxidation process, the masonry of P.2 and P.3 is greatly compromised in its structural integrity, presenting crack patterns and damages as those observed on the pillar P.1.

Therefore, the presence inside of pillars P.1, P.2 and P.3 of the west side of the cloister of metal reinforcement elements causes damages to their masonry due to oxidation phenomena (fig. 13); pillars P.4 and P.5, which have not been reinforced by means of metal elements are just little (the pillar P.4) or in no way (the pillar P.5) damaged (figs. 14.a,b), ensuring their full load-bearing function.

**Fig. 13:** Pillar P.3 greatly damaged, in virtue of the crushing in act and the internal presence of a oxidized metal tube.

- performing a different intervention of consolidation of the pilasters in order to obtain the same structural results but using different reinforcing materials, not susceptible to oxidation;
  - carrying out the chemical and the morphological characterization of the building materials of the masonry, in order to evaluate the compatibility between original materials and the reinforcing ones.
- Finally, the structural problems detected on the arches of the San Bernardino cloister are the result of design choices and wrong interventions performed in the past, as evidenced by the visible damages.

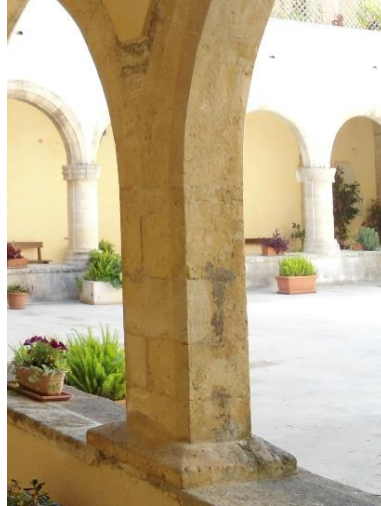
**Fig. 14.a**

Visual observation of the two pillars suggests that the second hypothesis seems to be the correct one. In fact, the masonry bodies P.4 and P.5, unlike the pillars P.1, P.2 and P.3, although subjected to equal loads show only few little cracks due to the overloading phenomenon in act.

**Figs. 14:** Examples of pillars placed along the west side: a) pillar P.4; b) pillar P.5.

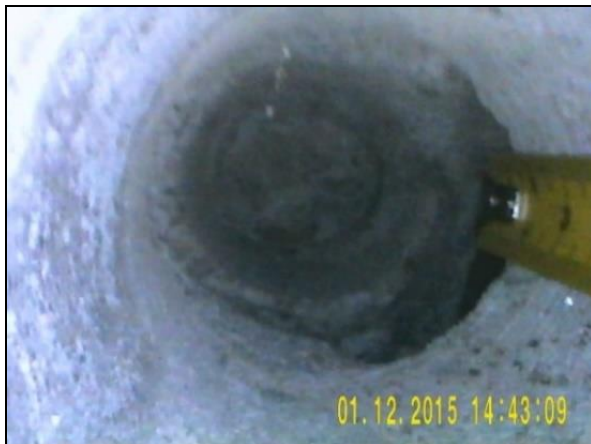
**Fig. 15.a**

The presence of reinforcement metal tubes inside of the pillars of the south and east sides of the cloister has been investigated. These pillars have cross-sections greater than those of the pillars of the west side; therefore, on the pillars of the south and east fronts have been detected lower internal stresses that attenuate the problems relative to crushing from overloading. Nevertheless, performing endoscopic tests on the pillar P.6 of the south side, a further metal tube placed in a off-center position respect to the geometrical axis of the masonry body has been detected (figs. 15.a,b). Its decentralized position has not allowed the corer to meet the internal tube (fig. 16), during the operation of core drilling previously carried out on this pillar.

**Figs. 15:** Endoscopic investigation through the pre existing hole on the pillar P.6: a)  $x \approx 10$  cm; b)  $x \approx 16$  cm.

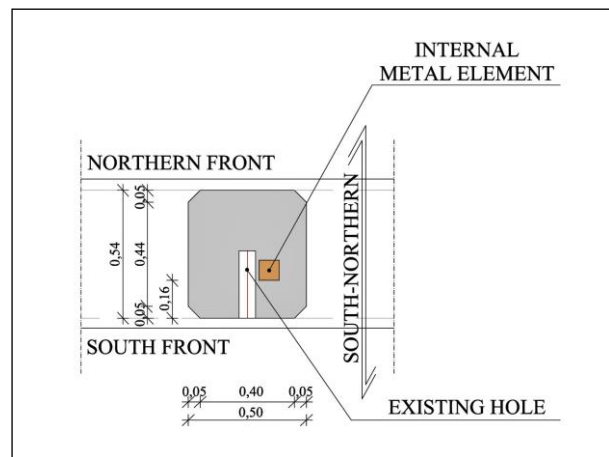
**Fig. 16:** Generic cross-section of the pillar P.6.
