Study of crack patters of historical masonry elements of the cloister of St. Bernardino and the church of St. Biagio in Amantea (Cs) by means of sonic tests

Ing. Renato OLIVITO*, Ing. Alessandro TEDESCO*, Ing. Giulia FORESTIERI**

UN PONTE TRA ARTE E SCIENZA: PASSATO, PRESENTE E PROSPETTIVE FUTURE

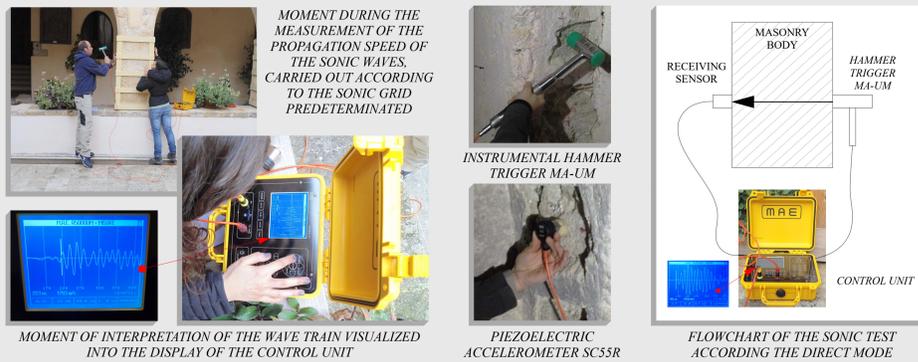
The sonic tests allow to determine the propagation speed of mechanical sound waves through the investigated masonry body. This is useful to obtain qualitative information about the compactness level of the masonry, the presence of cavities or cracks, and about the heterogeneity level of the materials crossed by instrumental waves. This non-destructive method of investigation is based on the generation of mechanical pulses with frequencies in the sound field (20-20000 Hz), by means to an appropriate instrument, which are received by a sensor (piezoelectric accelerometer) placed in a different point of the masonry structure. Both devices are connected to a control unit that converts analog signals into digital, but also displays the wave trains. Furthermore, the control unit returns automatically: the transit time of the waves through the masonry bodies; the crossing speed of the masonry (initially, it's known the space that divides the transmitter and the receiver). The sonic surveys applied to the architectures in masonry, especially historical ones, allow to obtain only qualitative results precisely because of the nature of the investigated material, which is highly heterogeneous and anisotropic. By virtue of this, the propagation speeds are very low if the crossed material is damaged and inhomogeneous, then if it is interested by the presence of significant empty spaces. Originally the execution of the sonic tests expected the identification of the "sonic grid", on the outer surfaces of the masonry elements to investigate, used like frame of reference to perform the instrumental measurements (Bufarini et al., 2010). Acquired the values of the propagation time and the propagation speed, it was possible to establish the degree of compactness of the masonry in relationship to different ranges of the propagation speed values v [m/s]. Then attributing to each range one color, it was possible to realize the color maps about the compactness levels of the masonry on the examined slender elements. The equipment used to perform sonic tests was composed of: a control unit MAE A5000UM S.N. M044771 to measure sonic impulses; an instrumental hammer Trigger MA-UM (transmitter) and a receiving sensor (piezoelectric accelerometer) SC55R with 55kHz frequency, both connected to the control unit through cable necessary to acquire data; connecting material (plasticine) in order to ensure the perfect adherence between the surface of the receiving sensor and the masonry support, allowing the passage of the sonic longitudinal waves in a continuous manner. The regulations in force relative to the execution of sonic tests are the UNI EN 12504-4. The surveys were conducted by the technicians of the NGT-TEST S.R.L. with legal headquarters in Catanzaro (Italy). The sonic tests were carried out in direct mode, known the thickness of the crossed masonry body (Cicchello et al., 2010). This mode consist in the emission and the receiving of the instrumental waves in corresponding points, located on two opposite faces of the masonry element in exam.

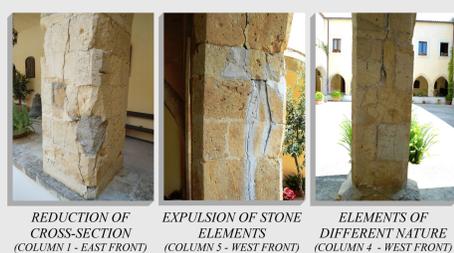
INSTABILITY FOR OVERLOADING IN ACTION ON THE ARCADES OF THE CLOISTER

The stability of the cloister elements has been compromised by possible effects of weathering and overloading. As a result, the load acting on some structural elements overcame locally their strength, with subsequent developments of cracks, leading towards a different equilibrium configuration. The crack pattern that occurred, was characterized by different features, depending on the cause that have generated it. The presence of cracks involves a decrease of the strength capacity of the masonry. The actual situation of the cloister shows a diffuse cracking pattern which requires an urgent strengthening intervention (Olivito et al., 2015).

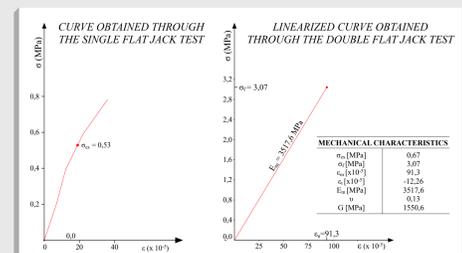
MECHANICAL CHARACTERIZATION OF THE MASONRY OF THE COLUMNS

The masonry of the arches was realized by means of calcarenitic stone characterized by an high porosity and alteration. Single and double flat jacks tests were carried out on a column of the east side of cloister. At first, the measurement of the exercise stress σ_{ex} was performed through the single flat jack test. Subsequently, on the same column the test with double flat jack was performed in order to evaluate the mechanical characteristics of the masonry: first crack tension σ_{cr} identified as the characteristic value of the compressive strength of masonry f_k ; longitudinal and transverse strains ϵ_{lm} and ϵ_t ; longitudinal elastic modulus E_m ; Poisson modulus ν ; shear modulus G.

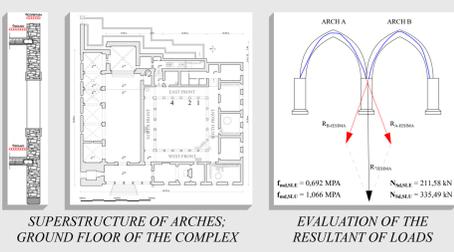
COMPRESSION CHECK CARRIED OUT ON THE COLUMNS

On the arches of the cloister affected by overloading were performed in-depth static analysis. At first the lines of pressure on the Gothic arches of the cloister have been built and the safety checks have been carried out in according to the Safe Theorem of Heyman. Subsequently, the resultants of the loads acting have been evaluated and the compression tests have been executed on the resistant sections of the masonry elements. The results of these checks have been analytically shown the instability for overloading in act, already observed. At the end, sonic tests have been performed in order to study the internal diffusion of the instability. The aim of these tests has been to realize a mapping about the structural integrity of the masonry bodies investigated. Three pillars of the east front of the cloister have been tested by means of sonic tests.

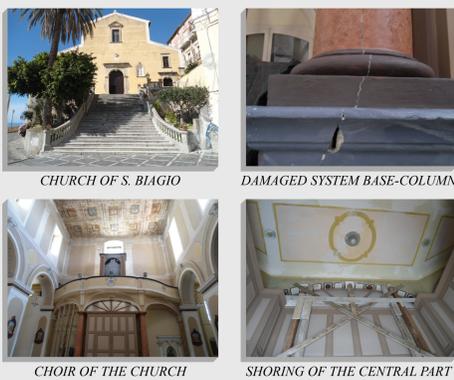
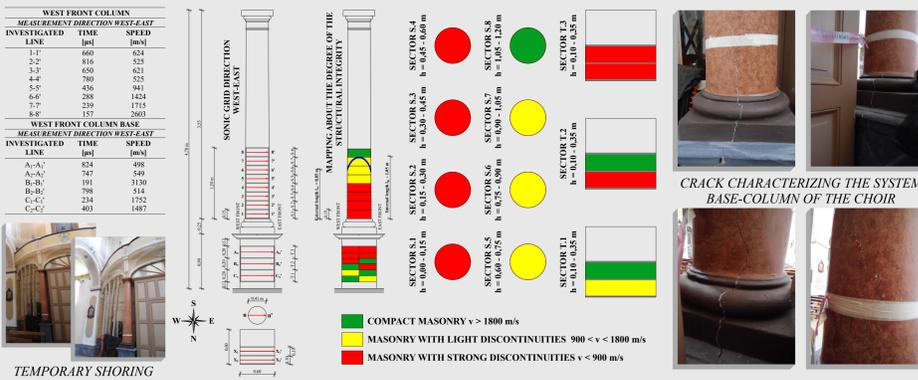
THE CHOR OF THE CHURCH OF SAINT BIAGIO IN AMANTEA (XVII CENTURY): DIFFERENT LENGTH OF THE CRACKS BETWEEN EXTERNAL SURFACE AND THE INSIDE OF THE MASONRY BODY

The church of San Biagio in Amantea was built during the seventeenth century and currently it doesn't show a good degree of conservation. The architecture is characterized by a series of damages, diffuse and extensive, which suggest structural mechanisms in act. The instability condition of the entire masonry structure totally compromises the functionality of the choir of church which along the south front is structurally connected to the principal facade, while on the northern front it rests on two columns in turn supported by two bases of parallelepiped shape. One of the two support columns and its base are interested by a crossing wide crack that develops starting from the base and goes back along the cylindrical body of the bearing masonry element. This dangerous crack has compromised the structural functionality of the system base-column, inviting the execution of appropriate interventions of temporary shoring for the choir. By means of sonic tests it was verified how the length of the external crack, measurable on the surface of the masonry element, is lower than the length characterizing the masonry of the column internally (there is not an exact correspondence between the two lengths, external and internal ones). This difference was verified through the sonic test carried out on the system base-column and defining a "sonic strip" with which to highlight the degree of integrity of the masonry.

As it was demonstrated through the sonic tests carried out, the results obtained about the characteristics of the masonry aren't exact, but through this type of test it's possible to determinate qualitative information which, if correctly interpreted, suggest the conservation state of the masonry with some precision. It has been demonstrated how, doing instrumental measurements in relationship to an appropriate sonic grid, or line, identified on the outer surfaces (by performing a careful pre-diagnosis phase), it's possible to build realistic mappings about the degrees of structural integrity about the masonry elements investigated. The resulting mappings will be more accurate if the discretization of the masonry volume will be more dense, therefore how much more small will be the elementary meshes that make up the sonic grid, or line, adopted. The information so obtained about the conservation state of the masonry could be used to define, in an optimal manner, interventions of structural consolidation, necessary to allow an improvement of the static functionality of the architecture.
