# WORLD HERITAGE AND DEGRADATION

Aversa | Naples 16 - Capri 17, 18 June 2016

### Investigations about the causes of structural damages of the St. Bernardino convent in Amantea (Cs)

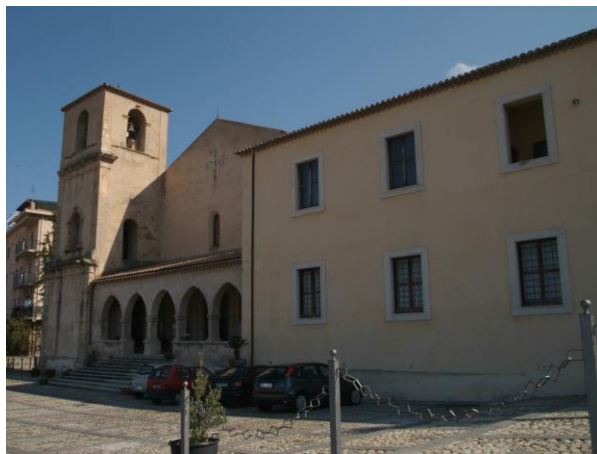
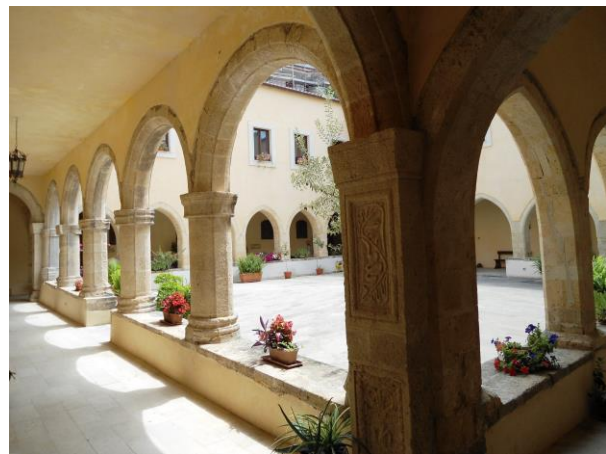
**Figs. 1:** The Franciscan complex of San Bernardino in Amantea: a) view from the parvis of the historical architecture; b) internal porch of the cloister.

The data reported so far proved irrefutably the overloading in act, explaining unequivocally most of the cracks and the signs of the instability detected on the arcades. However, through careful and detailed survey of the crack pattern characterizing the elements of the cloister, it has been possible to observe "unusual" cracks in correspondence of two pillars: in fact, these can be hardly ascribed to the crushing instability for the reasons explained below.

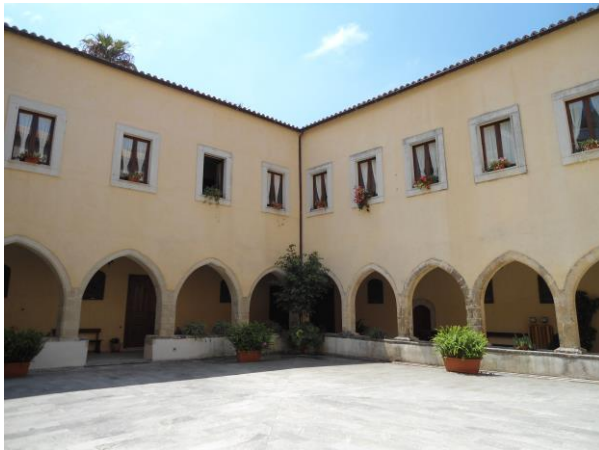
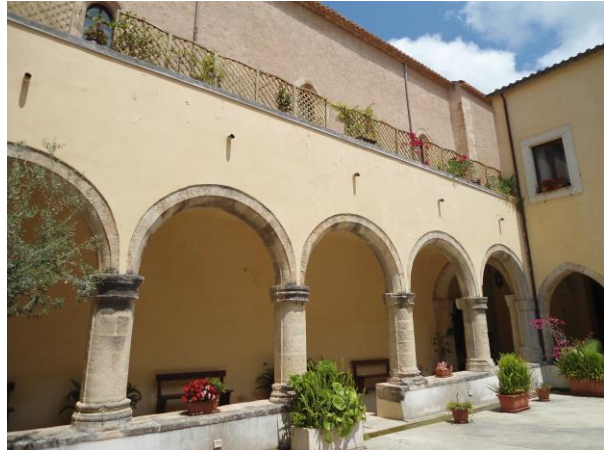
**Figs. 3:** St. Bernardino cloister: a) pointed arcades; b) Aragonese round arcades.

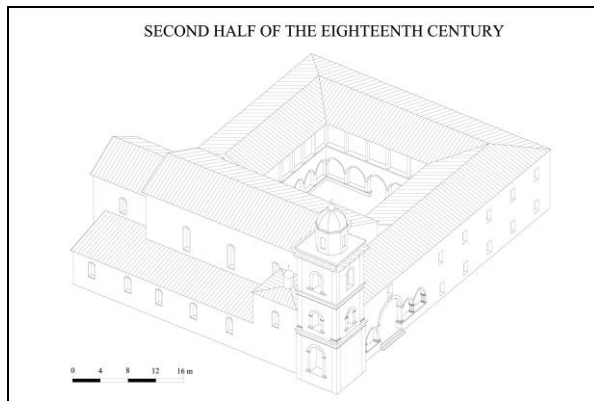
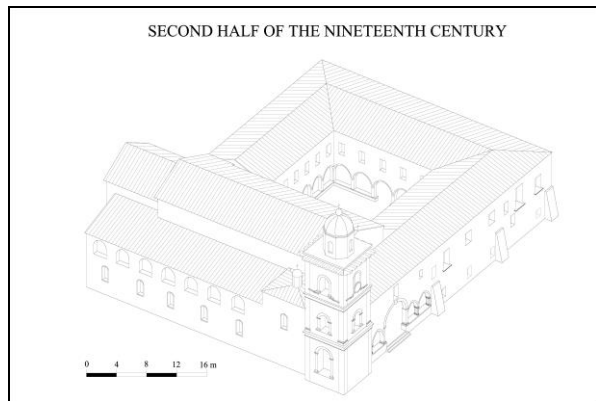
The closure of the upper open gallery was not the only cause of the overloading of the arches. Between the years 1948 and 1953, during the great post-war restoration directed by the Superintendent Gisberto Martelli, the original wooden floors were replaced with reinforced concrete floors, causing a new additional overload on the underlying load-bearing elements [9]. The situation, however, was further aggravated between the sixties and seventies of last century, when the first level of the convent was intended to several public uses (school, council archives, office of the C.I.M. and S.A.U.B.) [8]. These different uses of the conventual structure produced an increase of the loads in the exercise condition respect to those relative to the original use of the convent (residence of a religious family).

**Figs. 4:** Isometric reconstructions of the St. Bernardino complex related to different historical periods: a) the complex during the second half of the XVIII century, characterized by the open gallery on the pointed arches of the cloister; b) the complex during the second half of the XIX century, characterized by the closure of the open gallery and the realization of an internal gallery located along the first level of the convent.

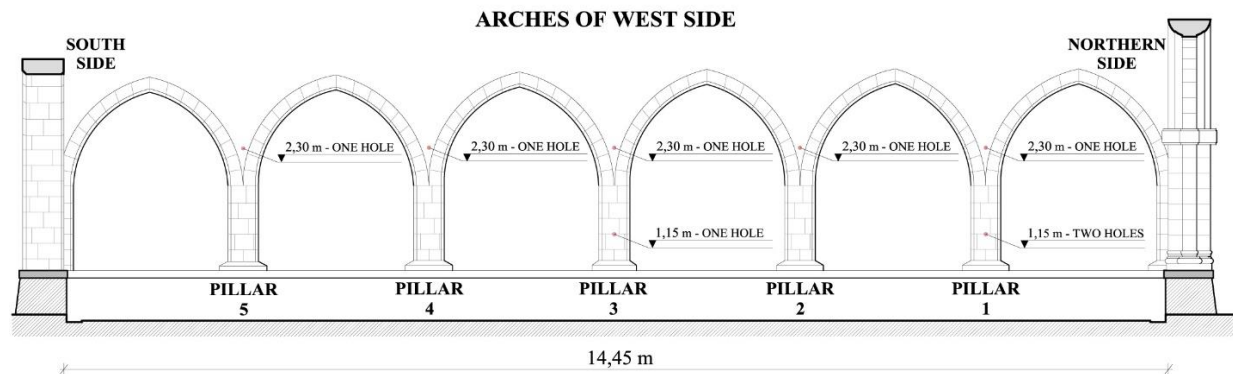
Through the inserting and progressive advancement of the optical probe inside the holes, it was possible to document the internal aspect of the investigated masonry bodies. The endoscopic tests have been carried out on the pillars of the west side of the cloister (n. 5 pillars), having a cross-section of dimensions 40x40 cm, realizing holes along the geometrical axis of the same ones at the elevations of 1,15 m (share corresponding to half height of the pillar) and/or of 2,30 m (higher share than the one of the superior section of the pillar) respect to the level of the ground floor of the internal porch (fig. 6).

**Fig. 6:** Arches of the west side of the cloister, with the details about the shares and the number of the holes carried out to perform the endoscopic investigations

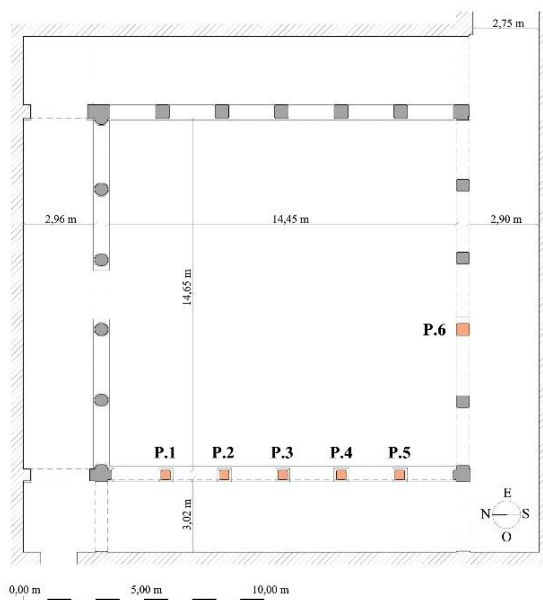
Moreover, a further endoscopic test was performed on a sixth pillar, located along the south side and having a cross-section of dimension 50x54 cm, on which a 54 mm diameter hole had already been practiced during the removal of a micro-carrot of masonry (fig. 7).

**Fig. 7:** Plan of the cloister of St. Bernardino, with highlighted the pillars on which endoscopic tests were performed.
